Korswagen PA, Bricker JD, Jonkman SN and Kolen B (2025) Experimental and numerical analysis of a masonry wall under hydrostatic and debris impact loads. Front. Built Environ. 11:1644699. doi: 10.3389/fbuil.2025.1644699

Experimental and numerical analysis of a masonry wall under hydrostatic and debris impact loads

Paul A. Korswagen^{1*}, Jeremy D. Bricker^{2,3}, Sebastiaan N. Jonkman² and Bas Kolen⁴

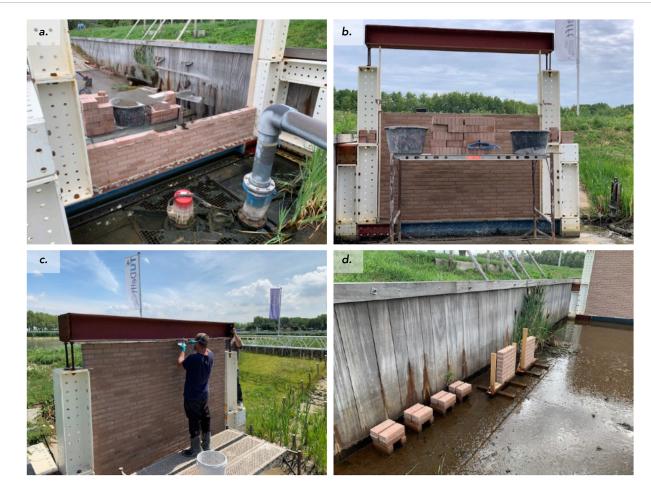
FIGURE 1
Construction process of the masonry wall and companion specimens by professional masons. View from the back (a), and front of the wall (b), including glueing of the last course to the top steel beam (c) and the companion specimens (d).

The wall was laid in a standard stretcher bond pattern, with each course offset by half a brick length. Mortar joints were 10 mm thick, made from a pre-mixed mortar consisting of cement, lime, and sand in a ratio of approximately 1.3:5.5:1 by weight. The water in mortar mix was adjusted slightly on-site to account for weather conditions during construction; see Figure 1.

A single-wythe masonry wall was constructed to replicate typical fired-clay brick walls commonly found in Dutch buildings (Jafari et al., 2017). The wall measured 2.7×2.7 m, with a thickness of 100 mm, and was built using standard 'waalformaat' fired-clay bricks measuring $210 \times 50 \times 100$ mm.

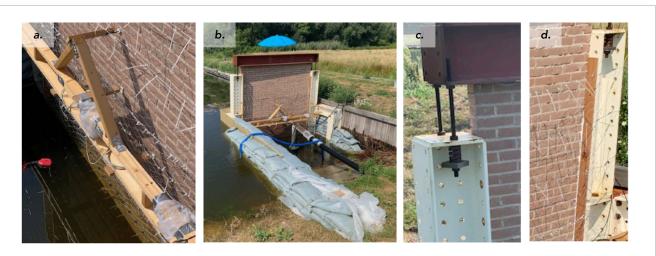
Experimental setup with steel rig, instrumentation, and water control system. (a) Timber support for 3 potentiometers, (b) dike made from sand bags and pump, (c) spring for application of vertical force on the masonry wall, and (d) timber support at the sides.

The experimental setup, shown in Figures 1, 2, included a custom-designed steel rig to provide vertical and lateral boundary restraints. Hydrostatic pressure was applied by gradually filling a water basin in front of the wall, while displacement sensors and pressure gauges monitored the deformation response throughout the tests.

To ensure the wall remained securely in place during testing, the first and last brick courses were glued to the bottom and top steel beams of the rig using two-component epoxy mortar. The lateral edges of the wall were left dry against the steel columns, with flexible timber profiles bolted to the rig to provide lateral support on the backside edges of the wall.

The masonry wall was installed within a custom-designed steel testing rig, engineered to replicate realistic boundary conditions and flood loading scenarios. The rig consisted of H-profile steel beams, bolted together to provide strong vertical and lateral supports.

- The bottom edge of the wall was fixed to the steel frame.
- The top edge was vertically restrained using a spring mechanism, which applied a pre-compression force to simulate the effects of vertical gravity loads. The maximum overburden on the wall was about 100 kPa and could be adjusted.
- The lateral edges were constrained using semi-flexible timber profiles, bolted to the rig, and filled with acrylic sealant to reduce movement and leakage.

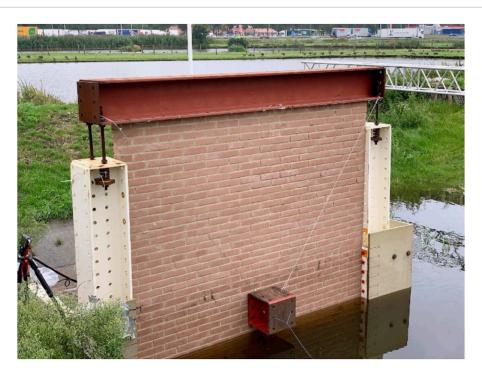
FIGURE 6
Steel cube setup for hard debris impacts.

Steel or "Hard" Debris: A 30 cm steel cube weighing 40 kg (see Figure 6) was suspended from the top of the rig and swung into the wall as a pendulum. This setup simulated hard, rigid debris such as vehicles or metal objects. The cube's velocity and impact energy were increased progressively, with repeated strikes at the same location to assess cumulative damage. Deformations were measured before and after each impact, and visual inspections were performed to document crack initiation, propagation, and any local failure of the masonry. Hard debris represents typically stiff debris such as vehicles or floating building components; see (Wüthrich et al., 2024) for an overview of debris carried by the flood in the Ahr Valley in 2021.

In contrast, the impacts from hard debris had a more severe effect on the wall's structural integrity. A 30 cm steel cube weighing 40 kg was suspended as a pendulum and swung into the wall at increasing velocities, reaching up to 3 m/s. The impacts concentrated energy into a small area of the wall, producing localised damage and progressive cracking (see Figure 12).

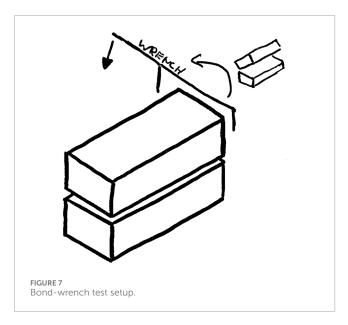
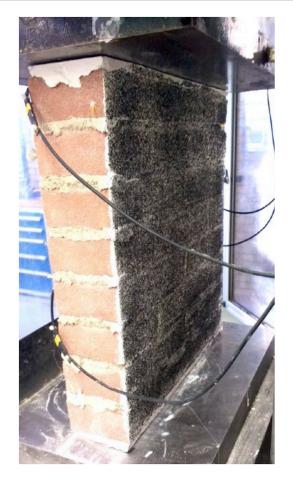
FIGURE 8

Compression wallet test in testing rig with Digital Image Correlation (DIC) black-and-white pattern.

To characterise the mechanical properties of the masonry, two types of small-scale tests were performed: 1) Bond-Wrench Tests: These tests measured the tensile bond strength of the mortar joints by applying a bending moment to the brick couplets (see Figure 7). The results were used to estimate the flexural strength of the wall in the vertical direction. 2) Compression Wallet Tests (see Figure 8): Two compression wallets were tested vertically to determine the masonry's compressive strength, Young's modulus,

and fracture energy (Jafari et al., 2017). These properties were critical for the calibration of numerical models. The companion material tests were performed in accordance with NEN-EN 1052–1 for compressive strength and stiffness determination, and NEN-EN 1052–5 for the tensile bond strength *via* the bond wrench method.
