Chen Y, Tian Z-G, Huang M-L, Gao Y-L,  
Wu Y-J and Yan G-H (2025) Field application  
of BOFDA-based distributed fiber optic  
sensing in static load testing of cast-in-place  
pile foundations.

# Field application of BOFDA-based distributed fiber optic sensing in static load testing of cast-in-place pile foundations

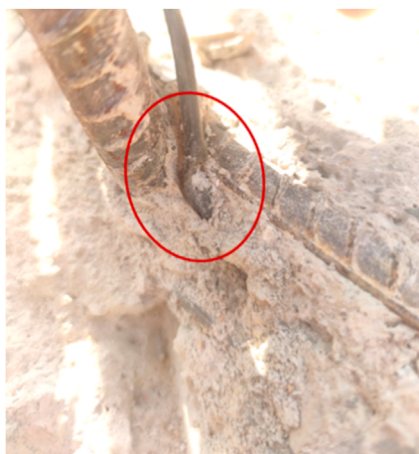
FIGURE 7  
Fiber damage caused by chiseling.

Although the metal-armored, strand-type strain-sensing cable protects the fiber with multiple metallic strength members, external impacts during construction—such as concrete casting and pile-head chipping (Figure 7)—can still cause damage. Fiber survivability, summarized in Table 5, was affected by construction activities (under the dual U-shaped layout, fibers are distinguished as Fiber #1 and Fiber #2).

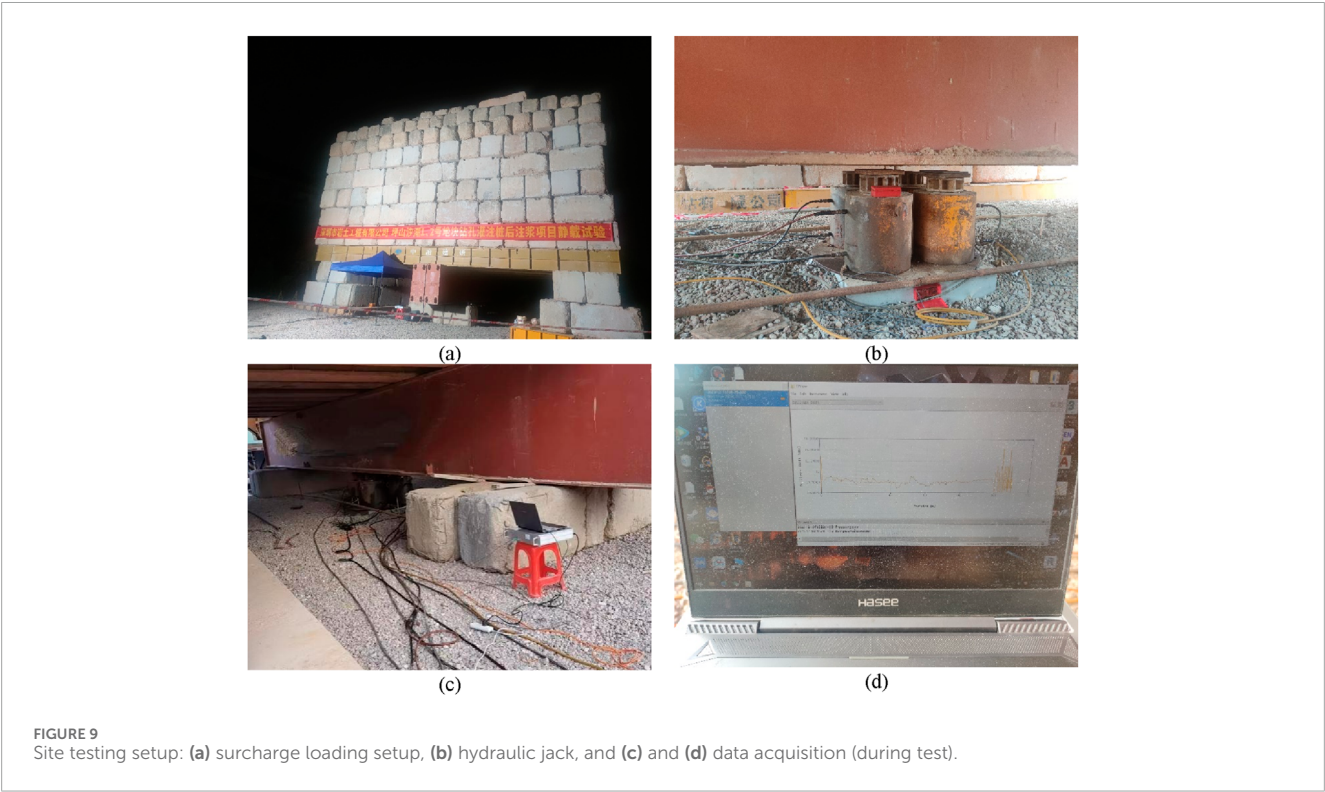
Data were acquired using a BOFDA demodulator (Figure 8), which enabled high-resolution strain acquisition, as specified in Table 6. The system offers 0.05 m maximum sampling resolution,  $\pm 2 \mu\epsilon$  strain accuracy, and a 50 km effective range, enabling high-density measurements along each pile. Acquisition parameters for each test pile are given in Table 7. During the staged static load tests, axial strain was recorded at each load increment, providing continuous strain profiles with more than 2,000 data points per pile. Work as shown in Figures 9–11.
