# Challenges and solutions in reinforcing self-built homes: experiences from Villa Maria del Triunfo, Lima, Peru

This study assesses H-shaped steel profiles (W8 × 31) as a retrofit solution for self-built dwellings in the Human Settlement (AA.HH). Ciudad de Gosen, Villa María del Triunfo (Lima, Peru). A four-part workflow was applied: i. field diagnosis with the Peruvian National Institute of Civil Defense (INDECI, by its Spanish acronym) checklist to classify seismic vulnerability and document construction pathologies; ii. numerical modeling in “Extended Three-Dimensional Analysis of Building Systems” (ETABS) v18 under Peruvian Standard E.030 to characterize story drift, torsion, and center of rigidity; iii. retrofit design that anchors and welds W8 × 31 profiles along critical load paths; and iv. experimental verification at National University of Engineering (UNI) Materials Testing Laboratory (LEM) following Peruvian Technical Standard (NTP) 350.405:2019 on representative columns and beams. Retrofitted specimens reached the testing machine’s maximum axial load of 686 kN (70,000 kgf) with only minor cracking between 245 and 324 kN (25,000–33,000 kgf), confirming concrete-steel c

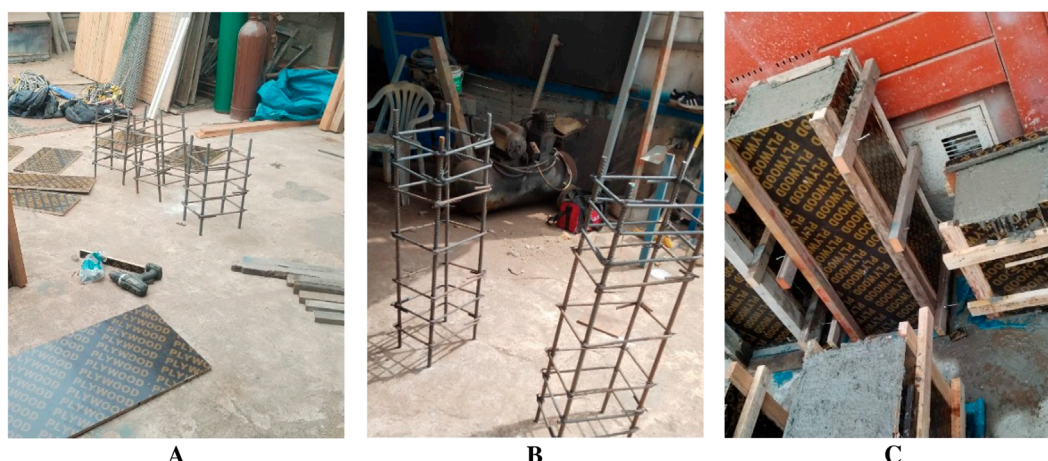
FIGURE 7

Manufacturing and assembly process for the concrete-steel composite system. (A) Type 1 column reinforcement (30 × 30 × 50 cm); (B) Type 2 column reinforcement (30 × 30 × 100 cm); (C) Type 1 and Type 2 reinforced-concrete columns.

epoxy coating to improve bond and provide corrosion protection. For experimental verification, three columns and two beams were fabricated to replicate the scaled dimensions of the intervened case: columns 50 × 30 × 30 cm and beams 100 × 35 × 30 cm. The consolidated dimensions are reported in [Table 14](#), which supplies the quantitative basis for the subsequent laboratory testing. [Figure 6](#) illustrates the measurement, mounting, and integration of the H-profile on the concrete members, confirming the constructability of the proposed system.

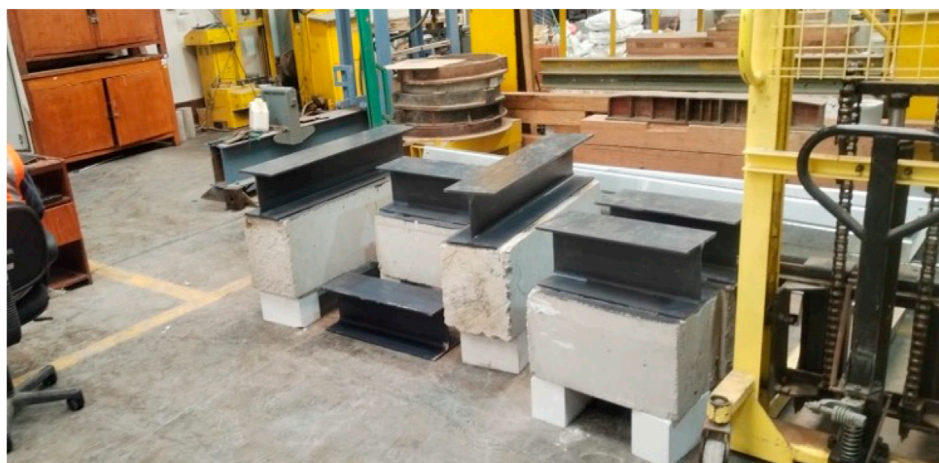
**FIGURE 8**  
Representative samples adapted and prepared for laboratory testing, showing the integration of the H-profile with reinforced concrete elements.

In the fourth phase, retrofitted structural specimens were prepared for experimental laboratory verification. The specimens were fabricated according to the adopted design dimensions, which included representative columns and beams of the analyzed dwellings. For this phase, 30 × 30 × 50 cm and 30 × 30 × 100 cm reinforced-concrete elements were produced, with longitudinal reinforcement and stirrups, in order to reproduce the structural configuration observed in the self-built dwellings under study. The designed steel profile was attached to these elements using mechanical anchors and an epoxy base, thus forming the concrete-steel composite system to be verified in the laboratory (Figure 7). Throughout this process, fabrication details, connections, and surface finishes were documented to ensure fidelity with the proposed structural model.
