Anatomy of the Naga City Landslide and Comparison With Historical Debris Avalanches and Analog Models

Lagmay AMF, Escape CM,
Ybañez AA, Suarez JK and
Cuaresma G (2020) Anatomy of the
Naga City Landslide and Comparison
With Historical Debris Avalanches and
Analog Models.

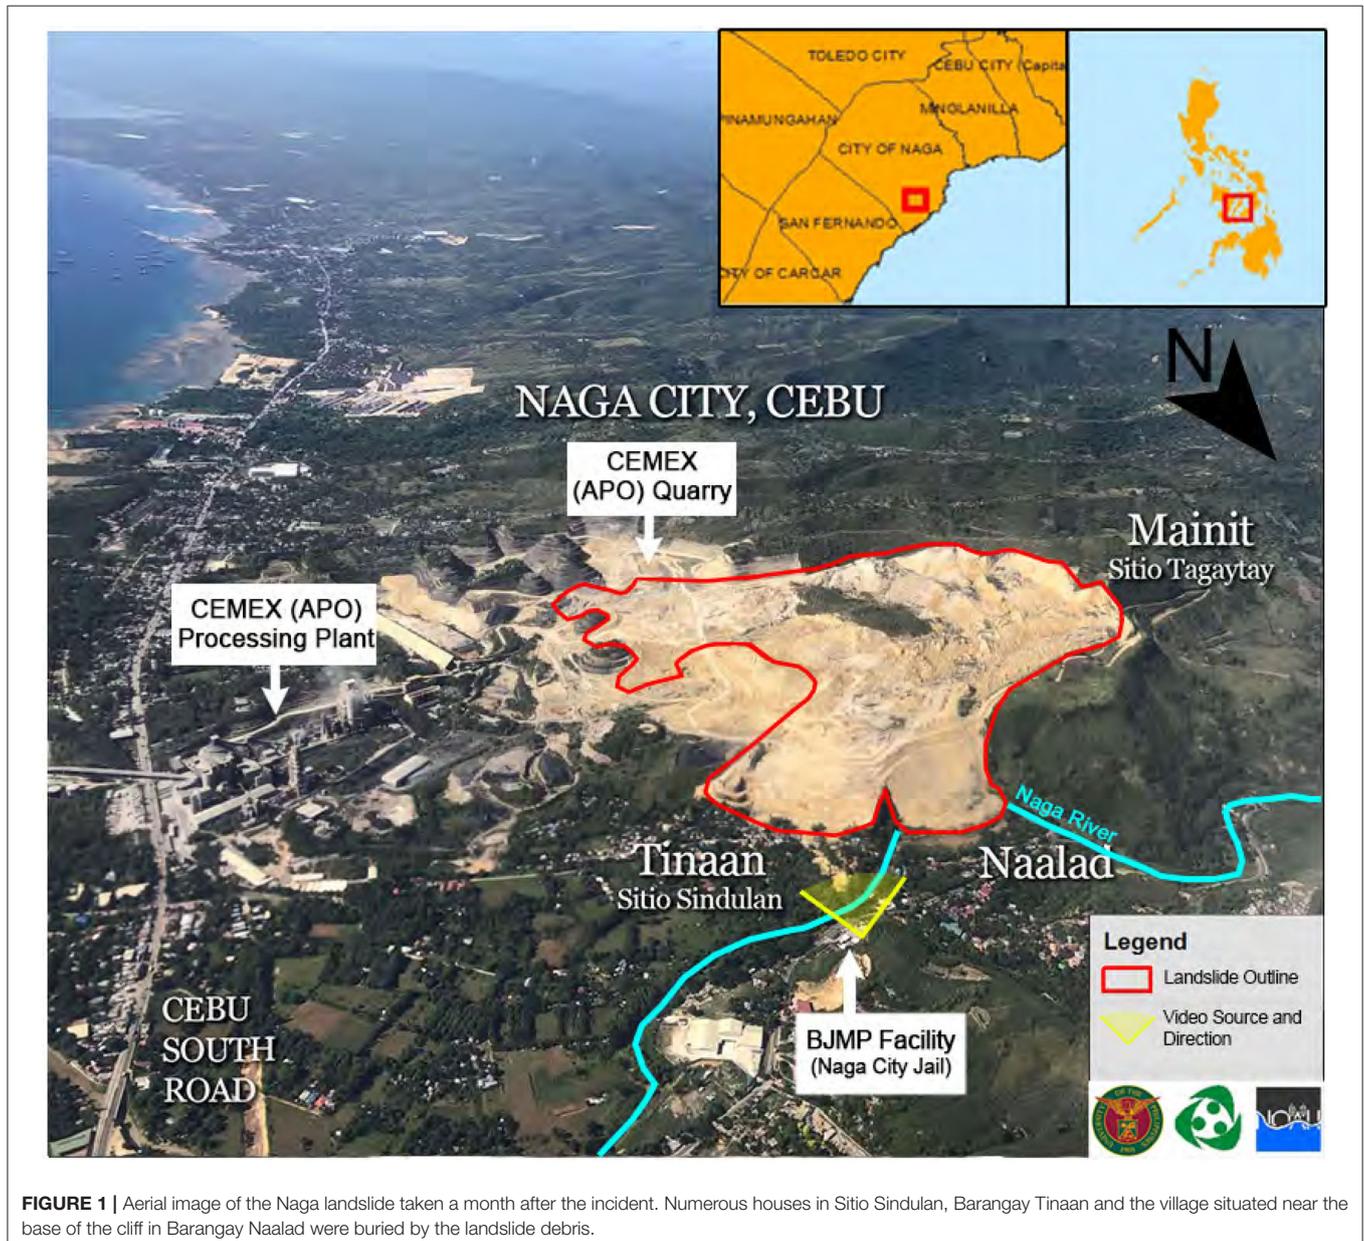
area at the base of a cliff in Barangay Naalad (**Figure 1**). Only residents in Sitio Tagaytay, situated near the headscarp of the landslide, were evacuated by authorities the night before the mountain collapsed.

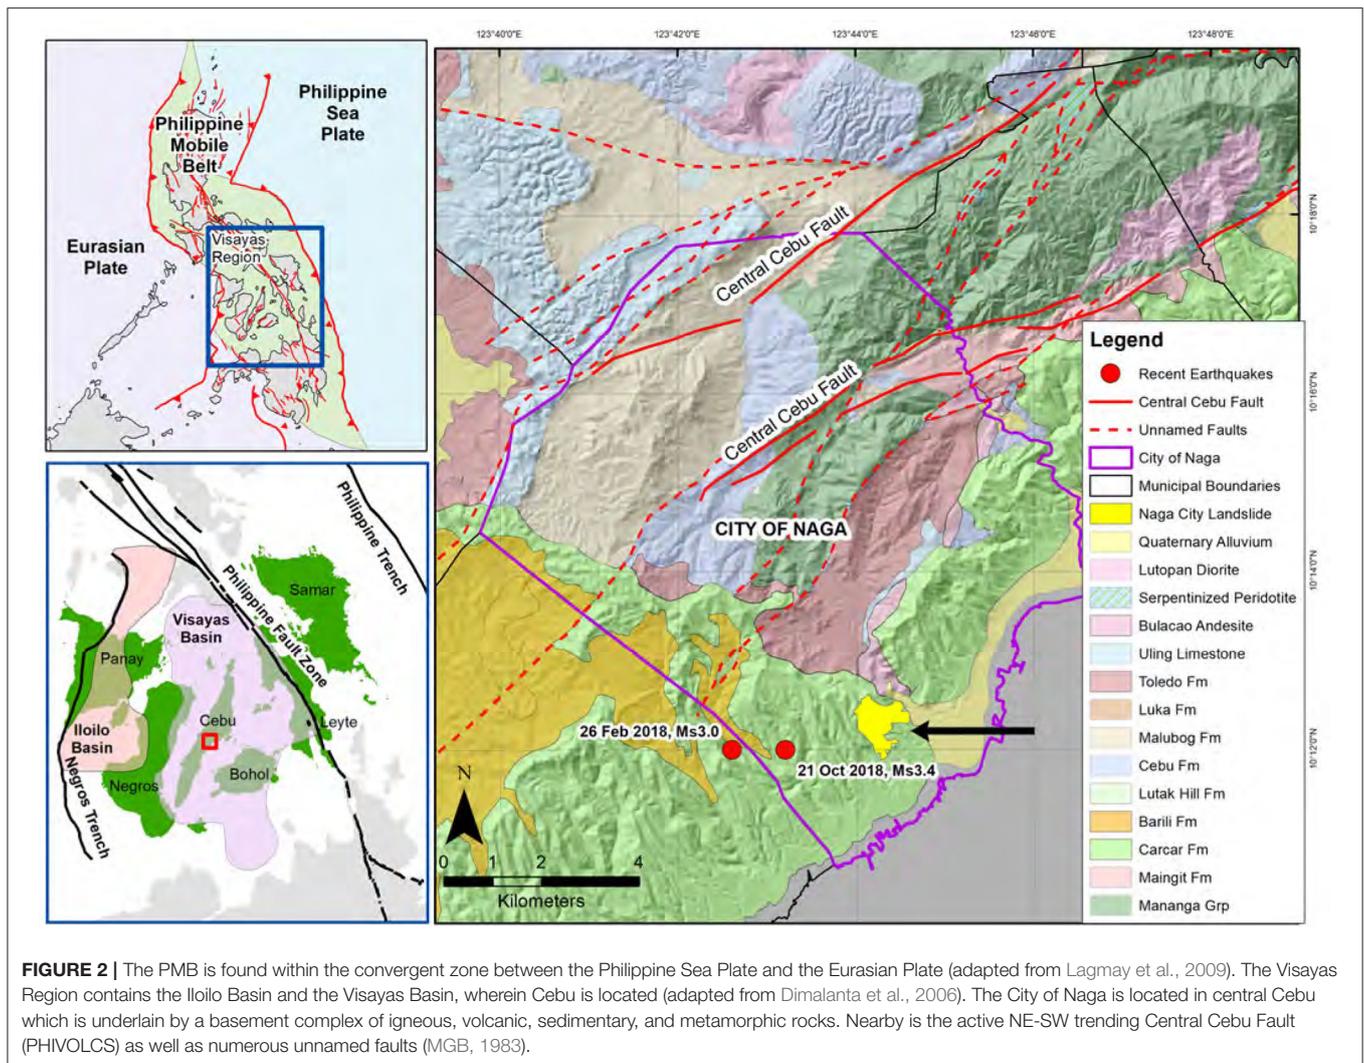
FIGURE 2 | The PMB is found within the convergent zone between the Philippine Sea Plate and the Eurasian Plate (adapted from Lagmay et al., 2009). The Visayas Region contains the Iloilo Basin and the Visayas Basin, wherein Cebu is located (adapted from Dimalanta et al., 2006). The City of Naga is located in central Cebu which is underlain by a basement complex of igneous, volcanic, sedimentary, and metamorphic rocks. Nearby is the active NE-SW trending Central Cebu Fault (PHIVOLCS) as well as numerous unnamed faults (MGB, 1983).

Central and the South Cebu faults (PHIVOLCS, 2016). The Central Cebu Fault passes through Naga City and is located 5.5 km west of the landslide. Other unnamed faults that were previously mapped (MGB, 1983) are consistent with the northeast trend of the Central Cebu Fault. Two earthquakes near the Naga Landslide area were recorded in 2018 by the Philippine Seismic Network with magnitudes 3.0 and 3.4, respectively. Both of these earthquakes were less than 33 km deep with the epicenters located within 3 km of the Naga landslide deposits (Figure 2).

there was a post-landslide tectonic earthquake with M_s 3.4 on 21 October 2018, which happened 1.5 km away from the landslide area (Figure 2). These may be related to the faults identified in the immediate area of the landslide as both are shallow earthquakes with depths less than 33 km (Figure 11).

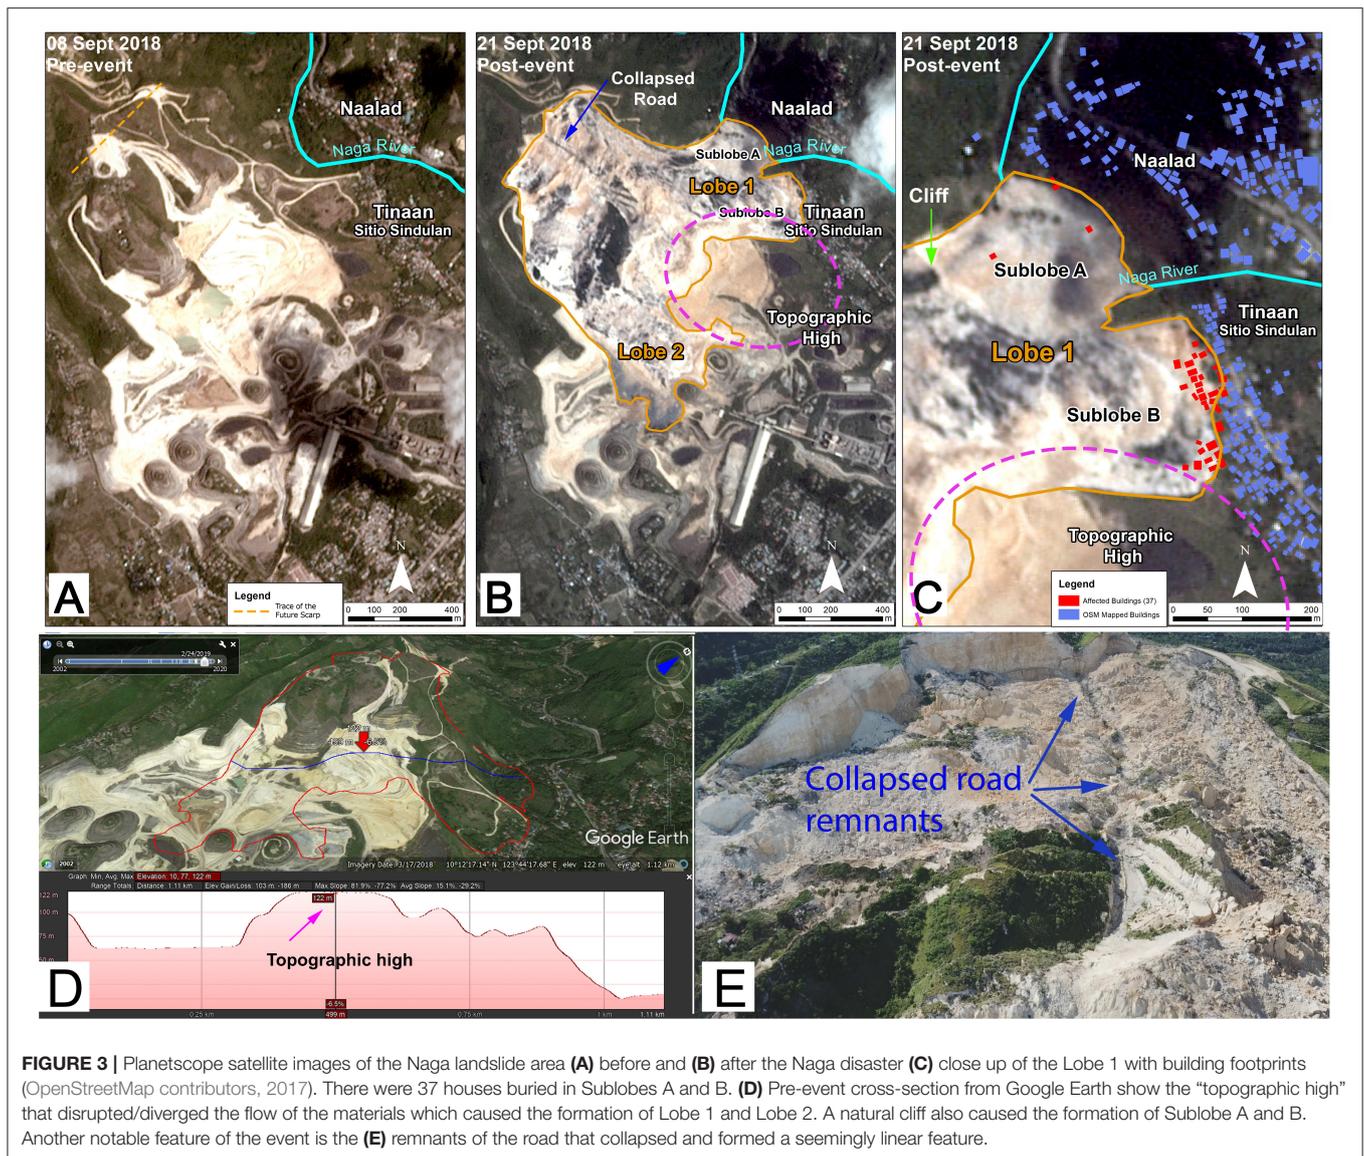
PlanetScope satellite images taken a day after the landslide event reveal a striking land cover change (Figures 3A,B). The areas that exhibit the biggest difference in surface conditions are those within the scarp area at the elevated regions of the quarry site and the two lobes of the landslide deposit in Barangay Naalad and Sitio Sindulan, Barangay Tinaan (Figure 3). The region near the headscarp was vegetated as clearly seen from the pre-disaster satellite image (Figure 3A). After the collapse and mass movement, the underlying limestone was largely exposed and is seen in the post-disaster satellite imagery with high albedo. At the distal end of the landslide deposit in Barangays Tinaan

and Naalad, 37 houses were buried in debris (Figure 3C). These residential areas at the toe of the landslide were buried up to 10 m as measured in the field and the DEMs. The Naga River was dammed as well. Quarried areas that were covered by the September 2018 Naga landslide deposit event did not show any significant change in NDVI values in pre- and post-disaster Planetscope imageries.

Noticeable in the debris field are large tilted blocks found at the medial to proximal section of the 1.2 km landslide (**Figure 5**). The tilted blocks or toreva blocks manifest as rows of broken material with their long axis perpendicular to the direction of the landslide. The largest blocks within the debris field have widths ranging from 120 to 350 m and traveled up to 220 m. Careful analysis of a linear feature (**Figures 3B,E**) that appears to divide the torevas in the proximal collapse zone of the landslide, reveal a road that subsided and whose parts were preserved as a large, intact landslide block (**Figure 3E**). The torevas at both sides of

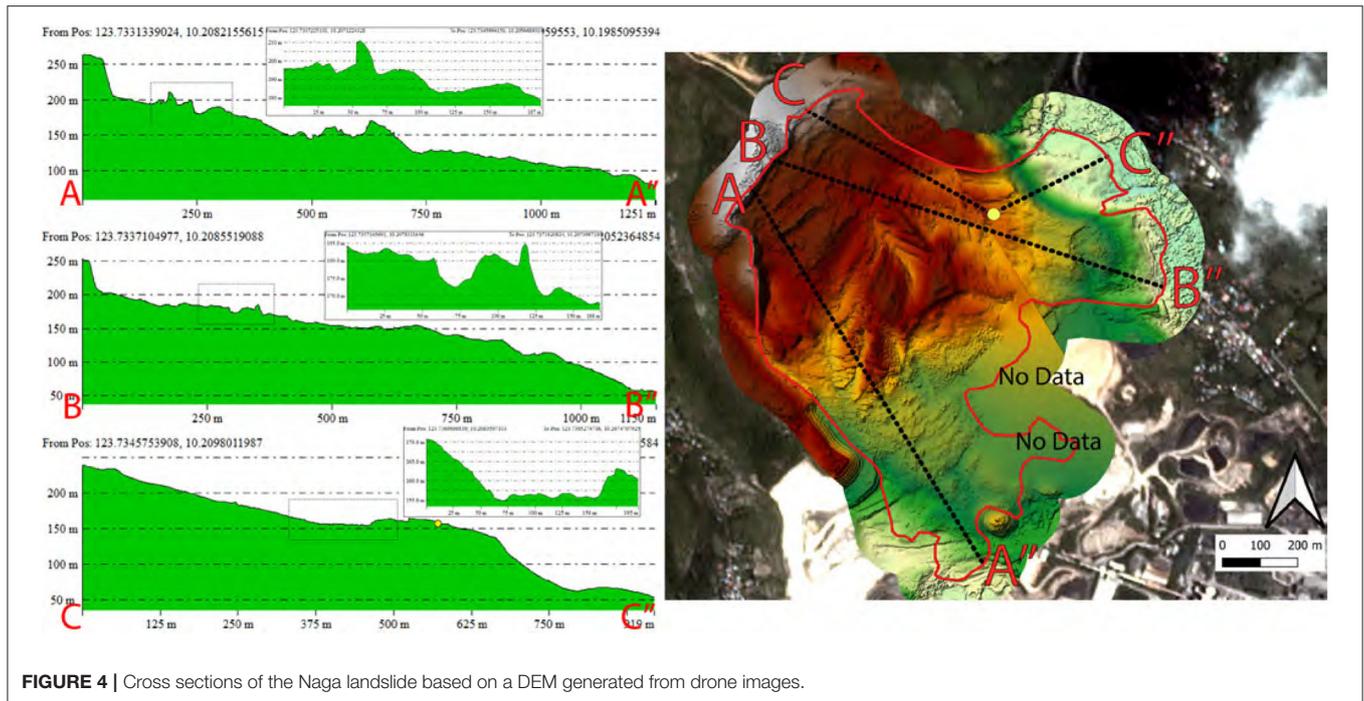
FIGURE 4 | Cross sections of the Naga landslide based on a DEM generated from drone images.

The post-event DEM used for detailed analysis of the Naga Landslide has a resolution of 33×33 cm. This post-event DEM was resampled to match the 1×1 m resolution of the pre-event LiDAR DEM to calculate the $11,000,000 \text{ m}^3$ volume of the Naga landslide. Cross-sections derived from the DEM, show prominent hummocks and rotated toreva blocks (**Figure 4**). Toreva blocks are commonly composed of one or more blocks that slide and retain the original stratigraphic sequence, whereas hummocks are mound features composed of block material in the surface with a form of conical shape and have a height of tens to hundreds of meters (Ui, 1983; Stoopes and Sheridan, 1992). Hummock sizes in the Naga deposit field decrease in dimension away from the headscarp, consistent with the descriptions in other debris avalanche deposits (Reiche, 1937; Ui, 1983; Crandell et al., 1989; Thompson et al., 2010; de Vries and Delcamp, 2015). The high-resolution DEM also reveals that the highest elevation of the failure is at 255 masl, whereas the elevation at the toe in Lobes 1 and 2 is 50 and 70 masl, respectively. In terms of maximum distance traveled from the headscarp, the landslide is measured at 1.1 km at Lobe 1 and 1.2 km at Lobe 2.

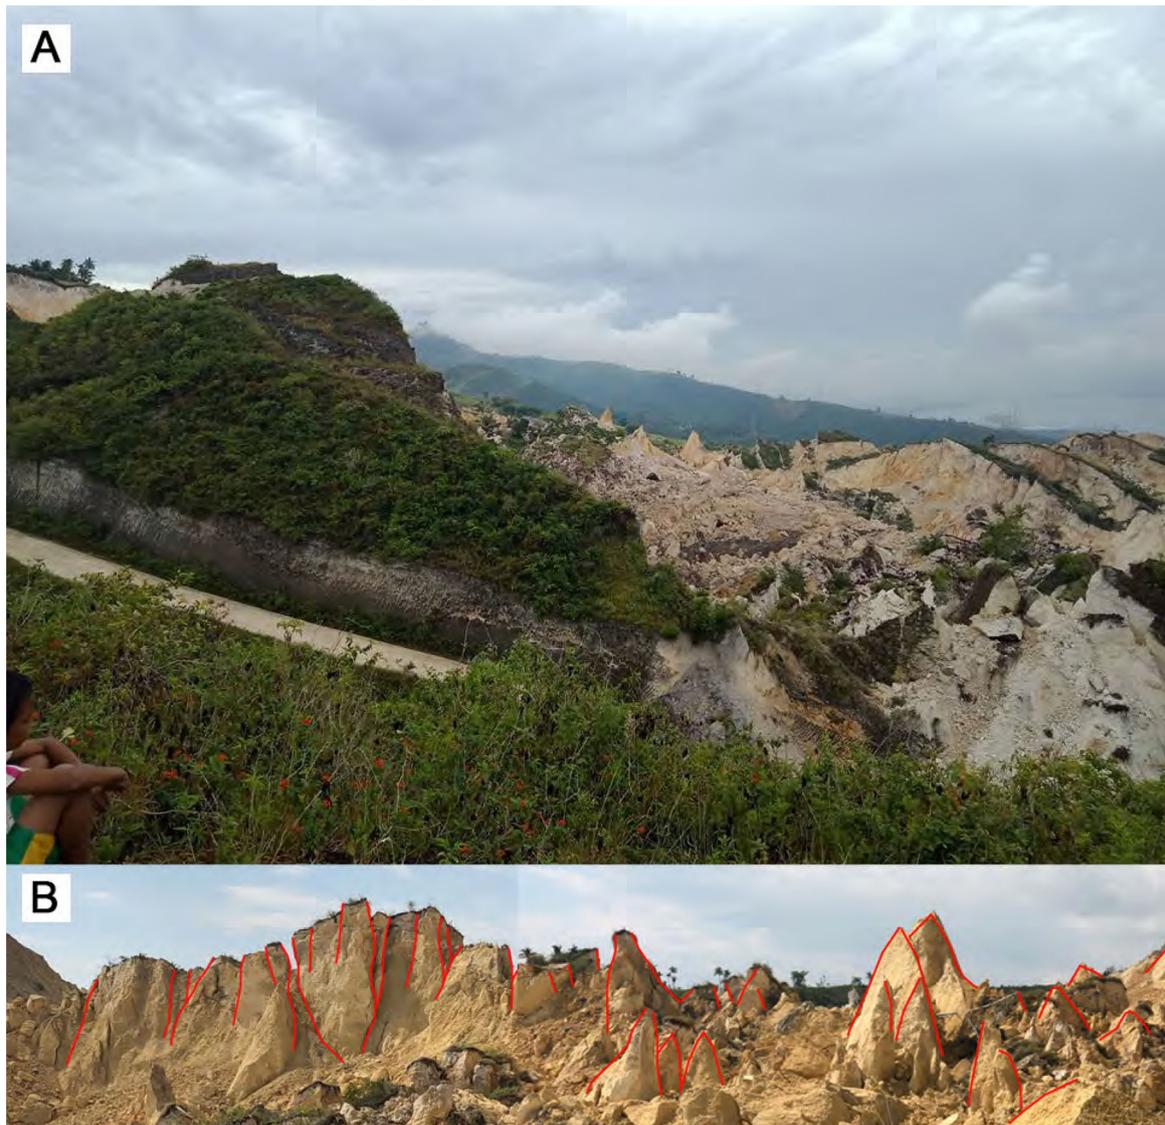
FIGURE 5 | (A) View looking north. Rotated torelva blocks at the proximal portion of the debris field (UP-CENVI, 2018). **(B)** View looking south-southeast. Horst and Graben structures and pinnacle hummocks formed due to faulting as the slide was extending.

The transport mechanism for the Naga debris avalanche requires low basal shear resistance to have formed the observed features in the deposit field. Extension during transport produced faulted blocks, including horst and grabens (Figure 5). Greater extension leaves behind the blocks, which are pinnacle in shape in 2D view and pointed conical shapes in 3D view. But the calcareous Carcar and Barili formations, which are sedimentary rocks can also be comminuted. The finer granular matrix surrounding the jigsaw-cracked blocks and those found in inter-hummock areas, are the broken (clastic) Carcar and Barili formation sedimentary rocks, which underwent extensive stretching. The hummocky topography of the Naga landslide, therefore, reflects the dynamics of emplacement, particularly the lower basal friction which becomes smaller for larger debris avalanche deposits because of the volume effect. Because of the presence of hummocks, much of the shear of the moving mass is interpreted to have been concentrated at the basal portion (Davies et al., 2010; de Vries and Delcamp, 2015), which are difficult to find in the deposit field.

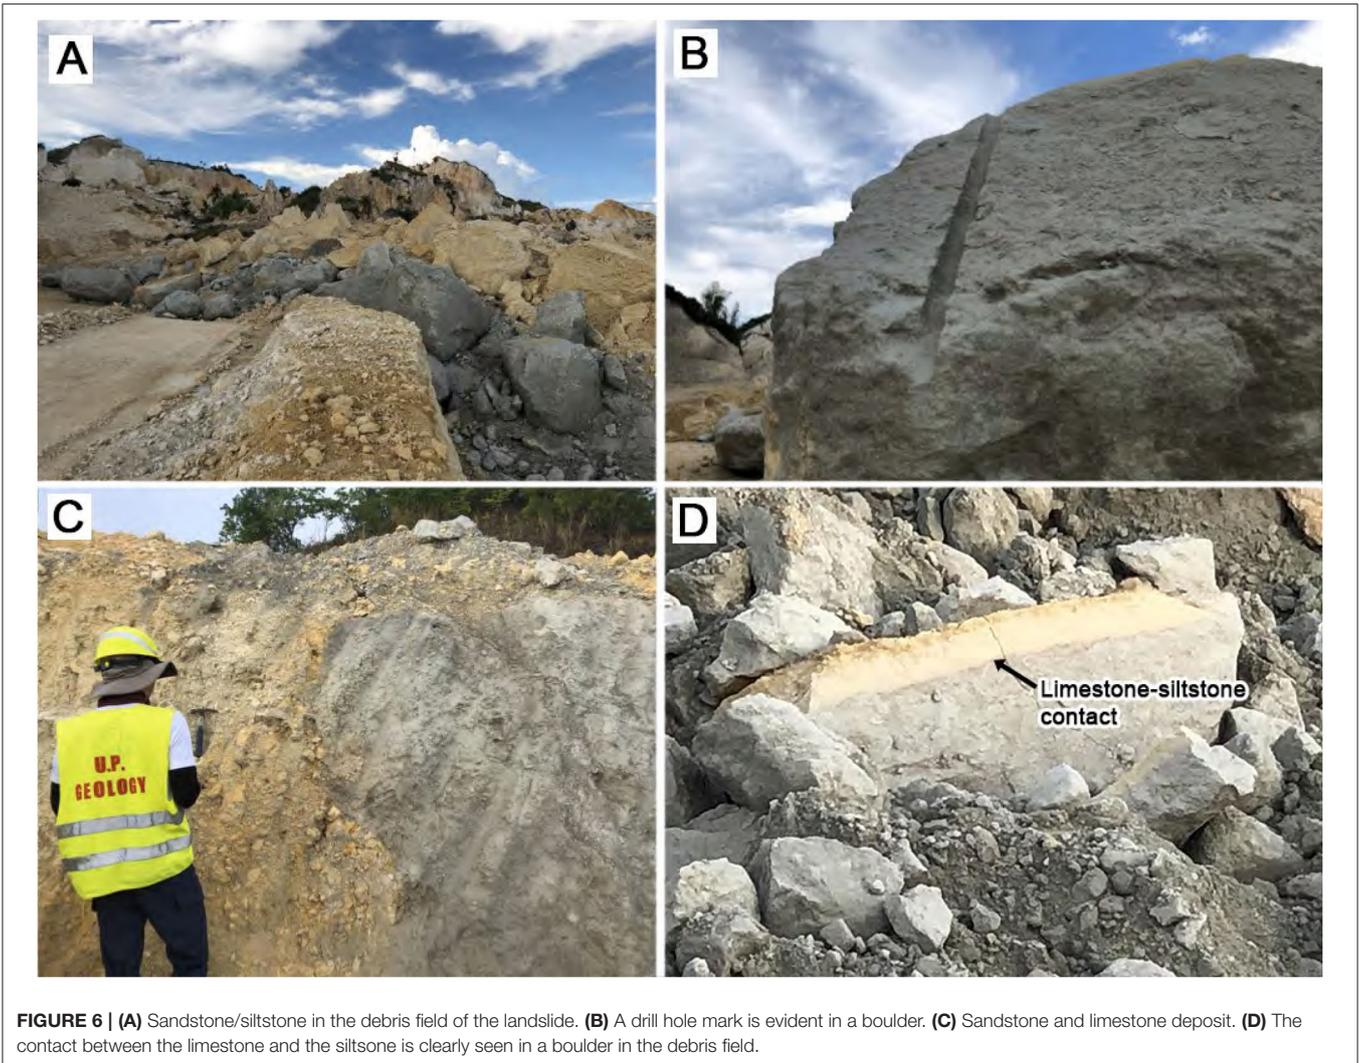
FIGURE 6 | (A) Sandstone/siltstone in the debris field of the landslide. **(B)** A drill hole mark is evident in a boulder. **(C)** Sandstone and limestone deposit. **(D)** The contact between the limestone and the siltstone is clearly seen in a boulder in the debris field.

The exposed calcareous formations within the landslide zone are more than 50 m thick and are underlain by a 3 m-thick sandstone/siltstone bed. This sandstone/siltstone bed, which is most likely the Marl component of the Barili Formation, is distinguished from the buff-colored limestone and appears in the quarry site of the Apo Tenement at 60 m elevation. Boulders of siltstone are also found in some areas of the debris field. The contact between the limestone and the sandstone/siltstone is clearly seen in some of the boulders within the avalanche deposit (**Figure 6D**).

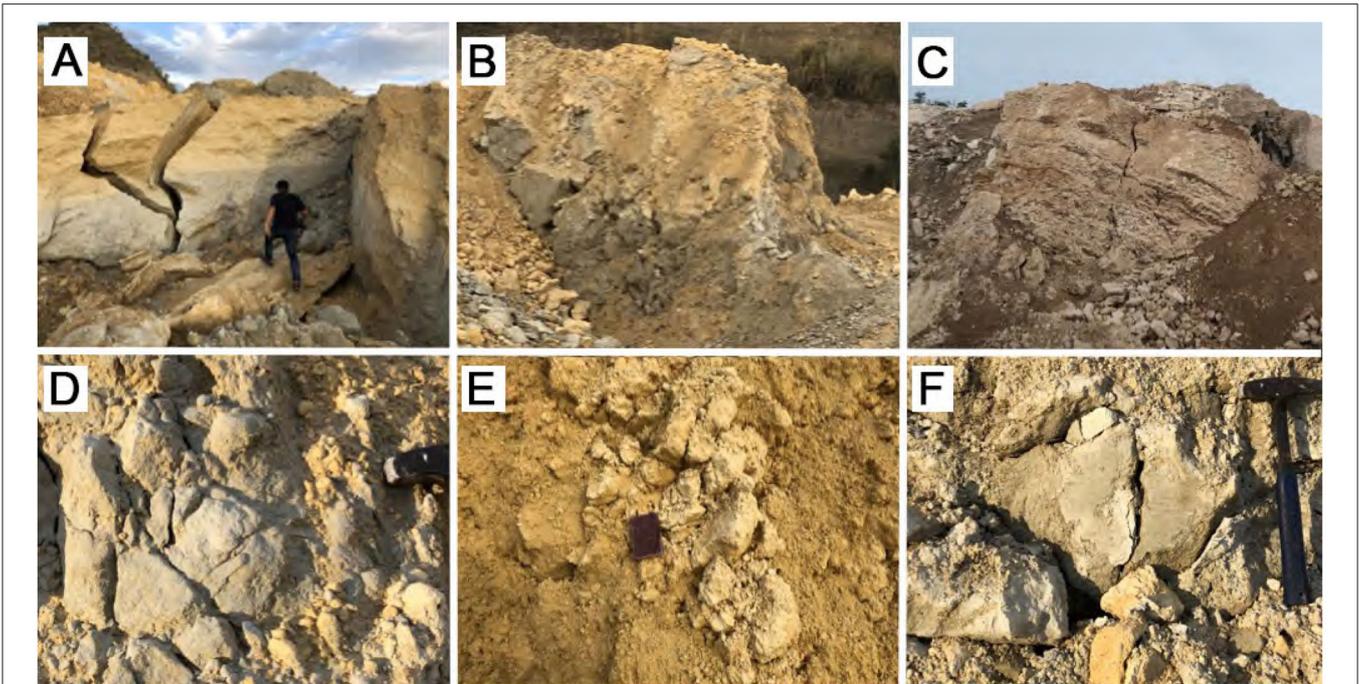
FIGURE 7 | (A–F) Boulders and blocks with jigsaw cracks.

Large mobilized intact blocks (MIB) are present in the proximal and medial portion of the landslide. Relatively smaller blocks compared to the MIBs, but still up to several meters in size, are scattered in the proximal and medial portions of the debris field with their sizes generally decreasing away from the headscarp. These blocks, no matter their size, commonly exhibit jigsaw cracks and are surrounded by a finer-grained matrix composed of fragmented limestone (**Figure 7**).

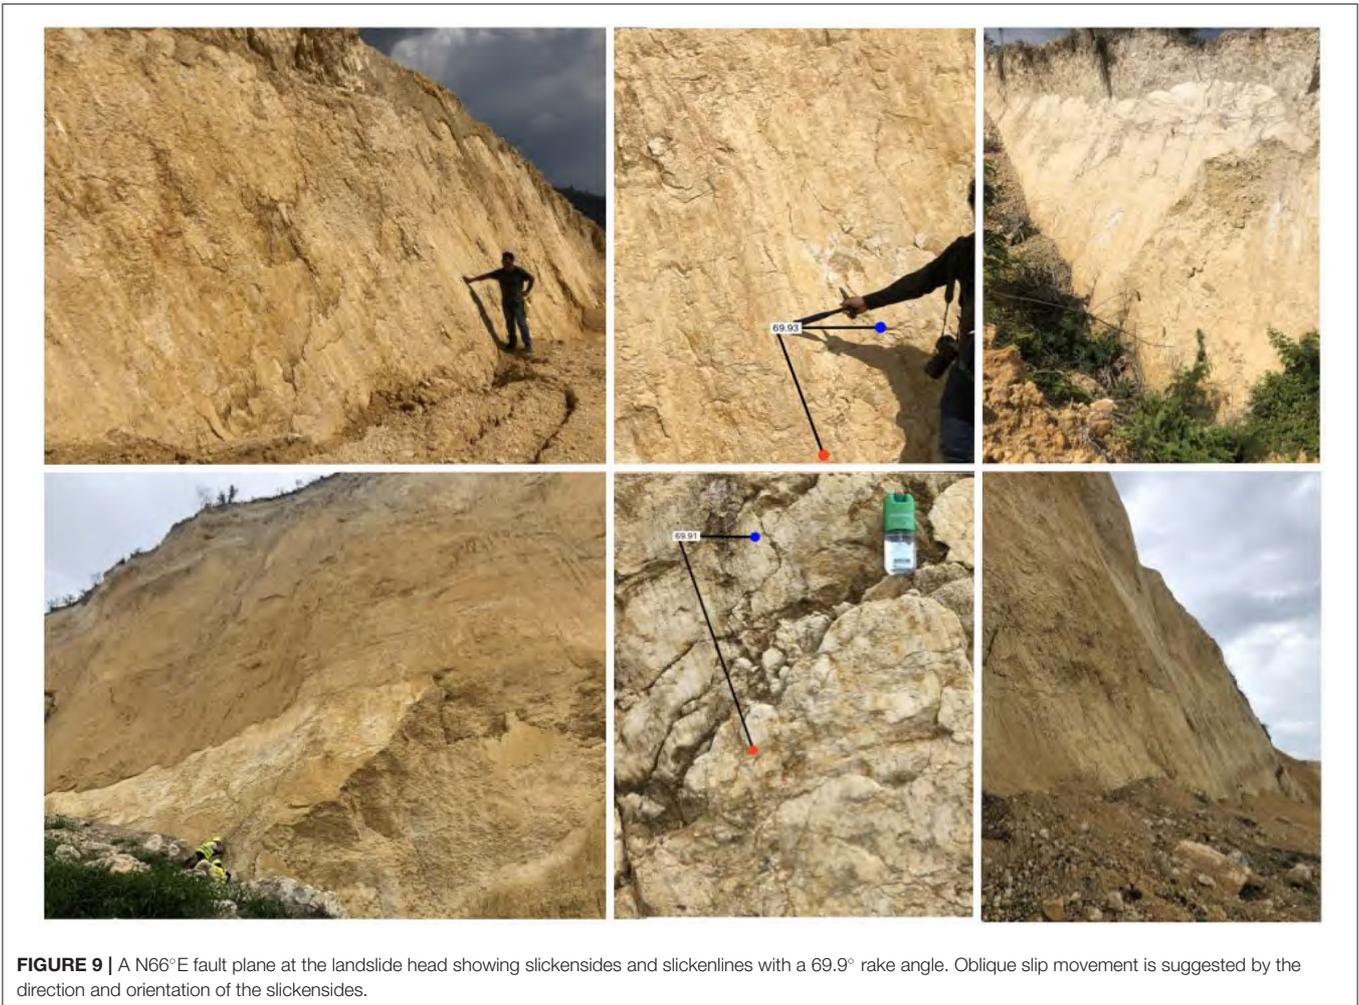
FIGURE 9 | A N66°E fault plane at the landslide head showing slickensides and slickenlines with a 69.9° rake angle. Oblique slip movement is suggested by the direction and orientation of the slickensides.

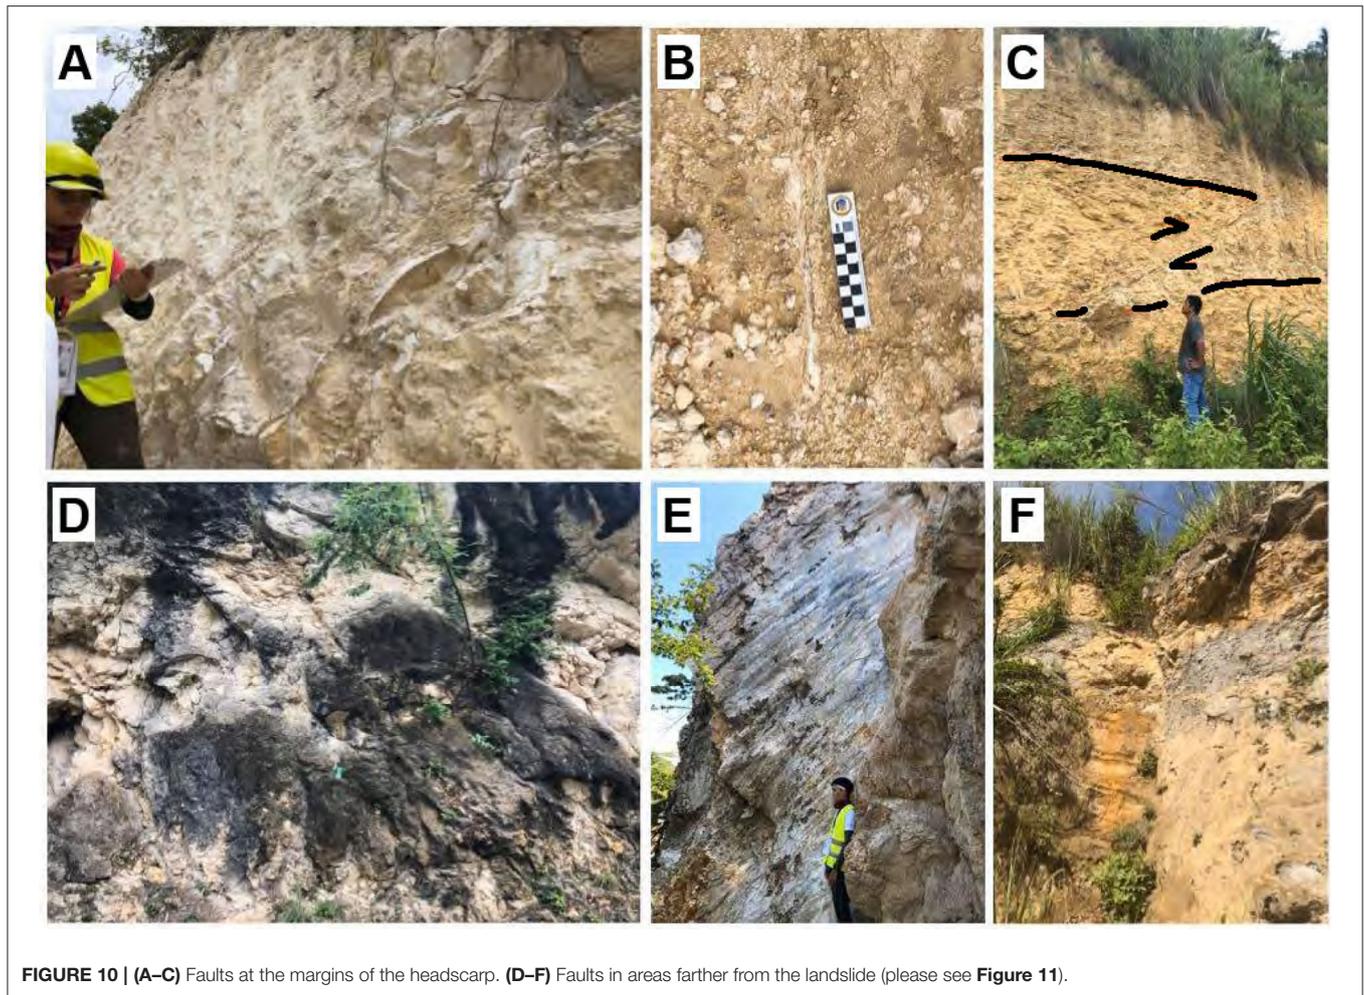
FIGURE 10 | (A–C) Faults at the margins of the headscarp. **(D–F)** Faults in areas farther from the landslide (please see **Figure 11**).

About 30 m at the back of the landslide scarp, faults were also observed. Generally, northeast-trending fractures are also present in the north and southern margins of the headscarp whereas numerous northeast-trending tension cracks were observed on top of the head wall that continue to widen (Figure 10). The entire area of Naga City has numerous faults that are mainly oriented northwest or northeast directions (Figure 11). These faults, however, maybe of various ages

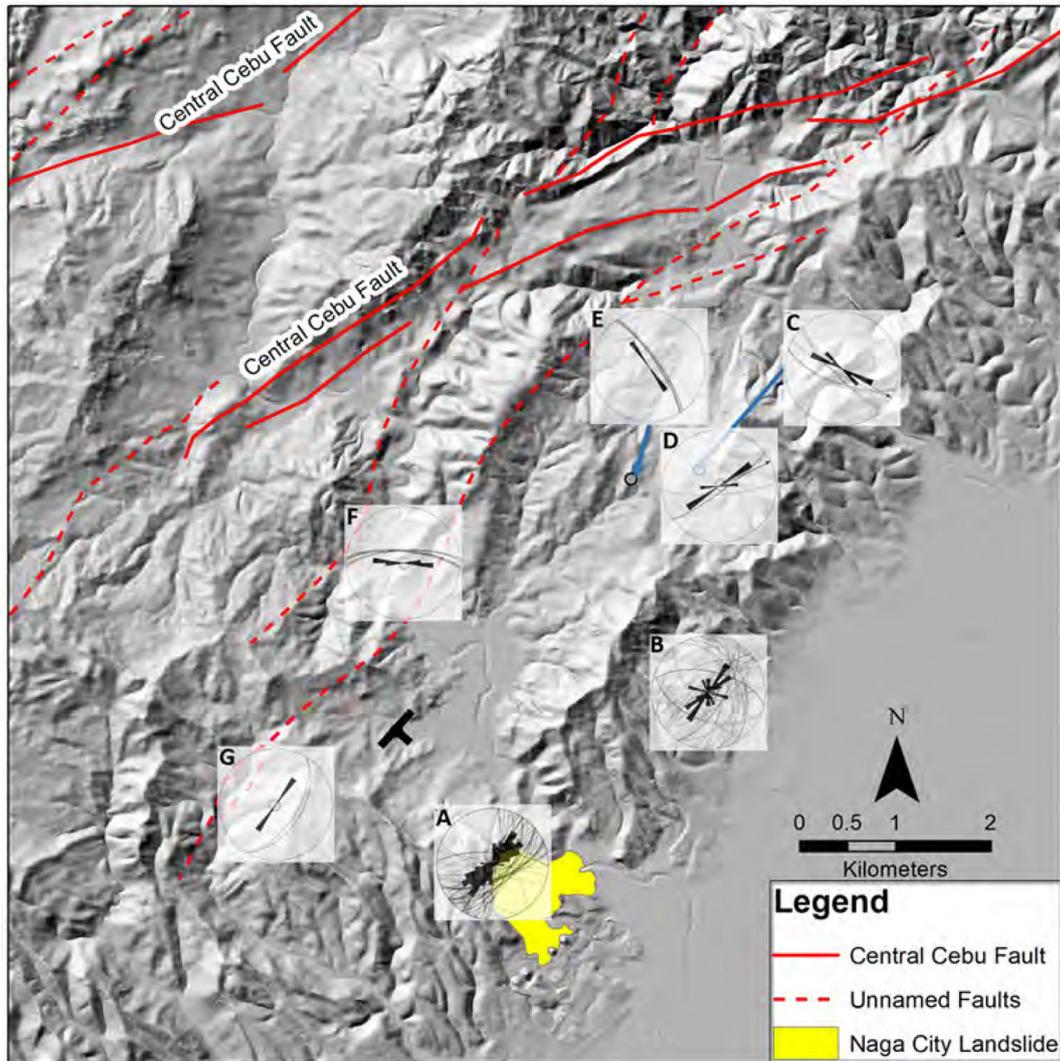
FIGURE 11 | Stereoplots and rose diagram plots of structural measurements in Naga City. **Figures 10A–C** found in rose diagram A. **Figure 10D** in rose diagram B. **Figure 10E** in rose diagram E. **Figure 10F** in rose diagram D.

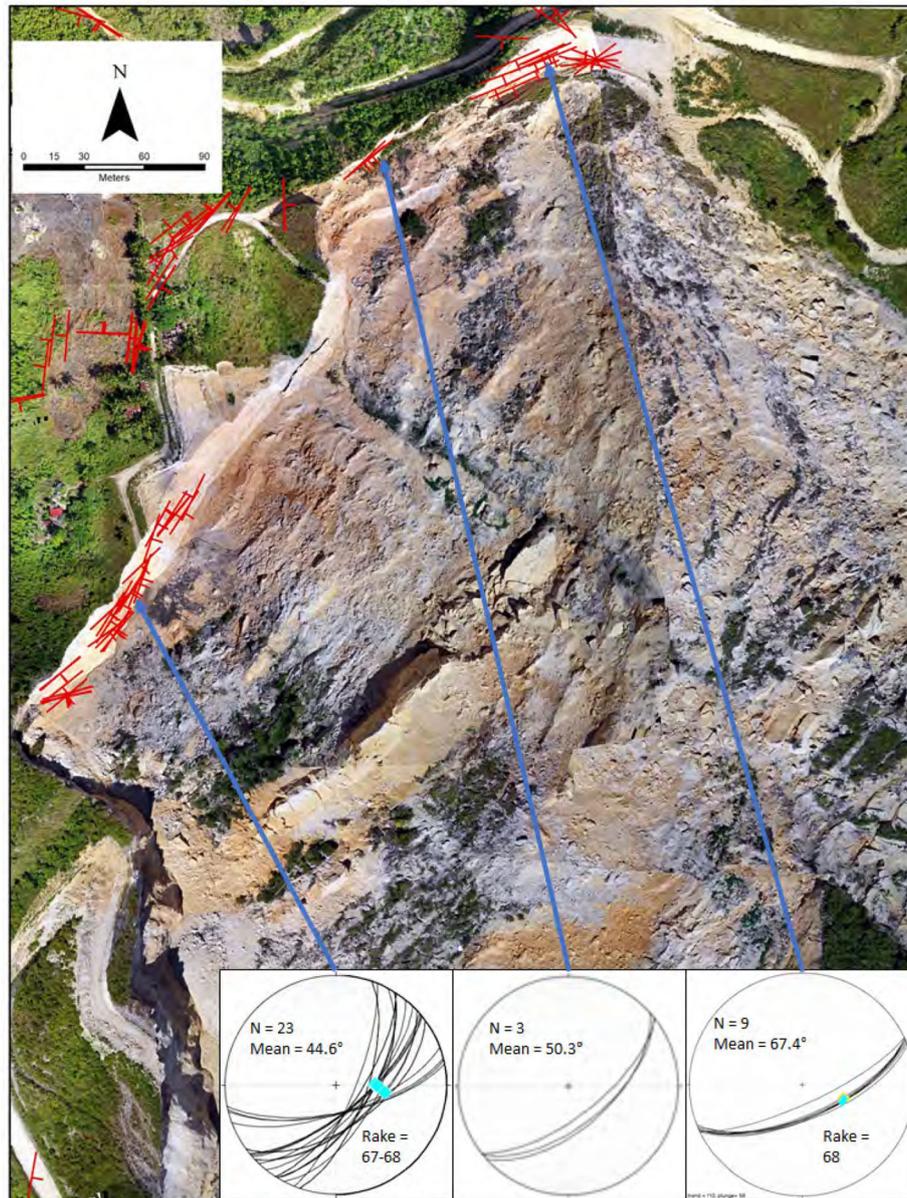
FIGURE 12 | Landslide head wall with fault measurements. The image is an orthomosaic map overlain on a DEM image.

given the range of rock types with various ages they cut through. Of particular interest are the set of fractures that have a general northeast direction, which correspond to the northward projection of the strike of the Naga landslide head wall (**Figure 12**).

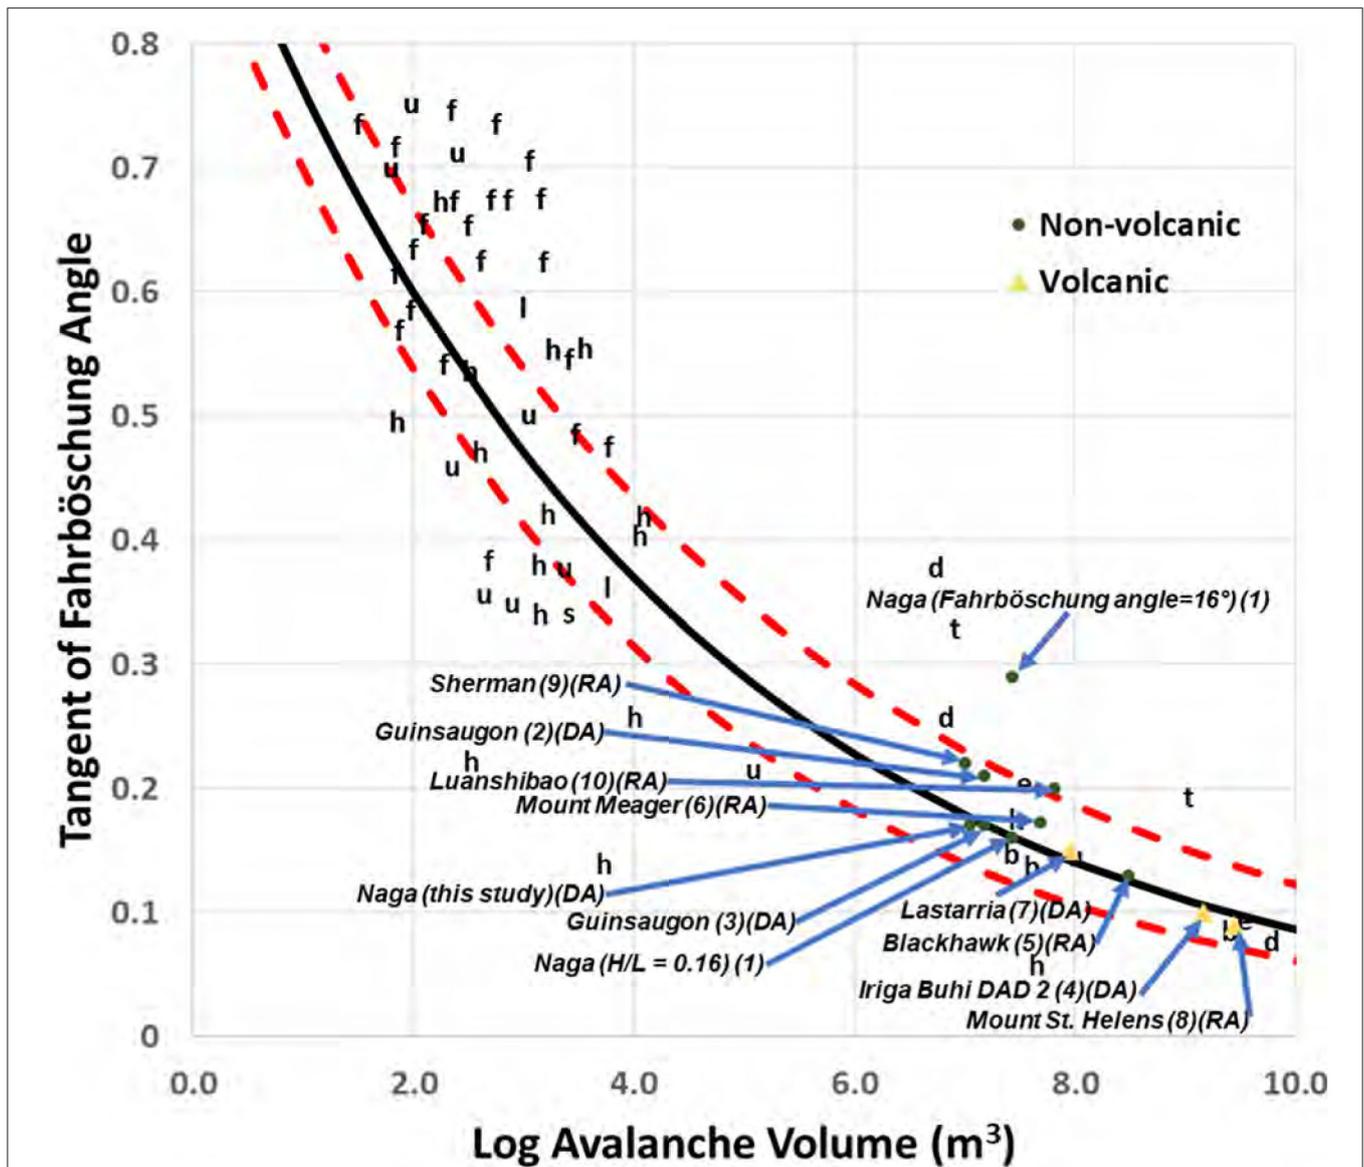
FIGURE 13 | Modified plot of debris flow and debris avalanche volume vs. tangent of reach angle for 71 events from Corominas (1996) and additional data. Labels correspond to the obstacles and topographic constraints of the path: f, dense forest; l, open forest; s, scree deposit; b, bends; d, deflections; t, toe thickening in a fan; h, channeling; w, opposing wall; u, unobstructed with free lateral extension. Black line represents the regression equation derived from the dataset whereas the red dashed lines show its corresponding upper and lower limits. Additional data are included to show how the Naga Landslide fits in the global context of debris and rock avalanches. References are as follows: (1) Catane et al., 2019, (2) Evans et al., 2007, (3) Lagmay et al., 2008, (4) Paguican et al., 2012, (5) Johnson, 1978, (6) Guthrie et al., 2012, (7) Naranjo and Francis, 1987, (8) Voight et al., 1983, (9) McSaveney, 1978, (10) Wang et al., 2018 whereas DA and RA stand for Debris Avalanche and Rock Avalanche, respectively.

The H/L ratio of the Naga landslide yields a Fahrböschung angle of 9 deg. Using this angle and the measured volume of 11,000,000 m³ from DEMs, the Naga landslide deposit plots in the field of

debris avalanches together with 71 similarly classified events out of the 204 landslides in the global dataset used by Corominas (1996) (Figure 13). Based on the regression equations for each type of landslide, the 2018 Naga landslide event falls under the category of debris avalanches with a 95% confidence interval.

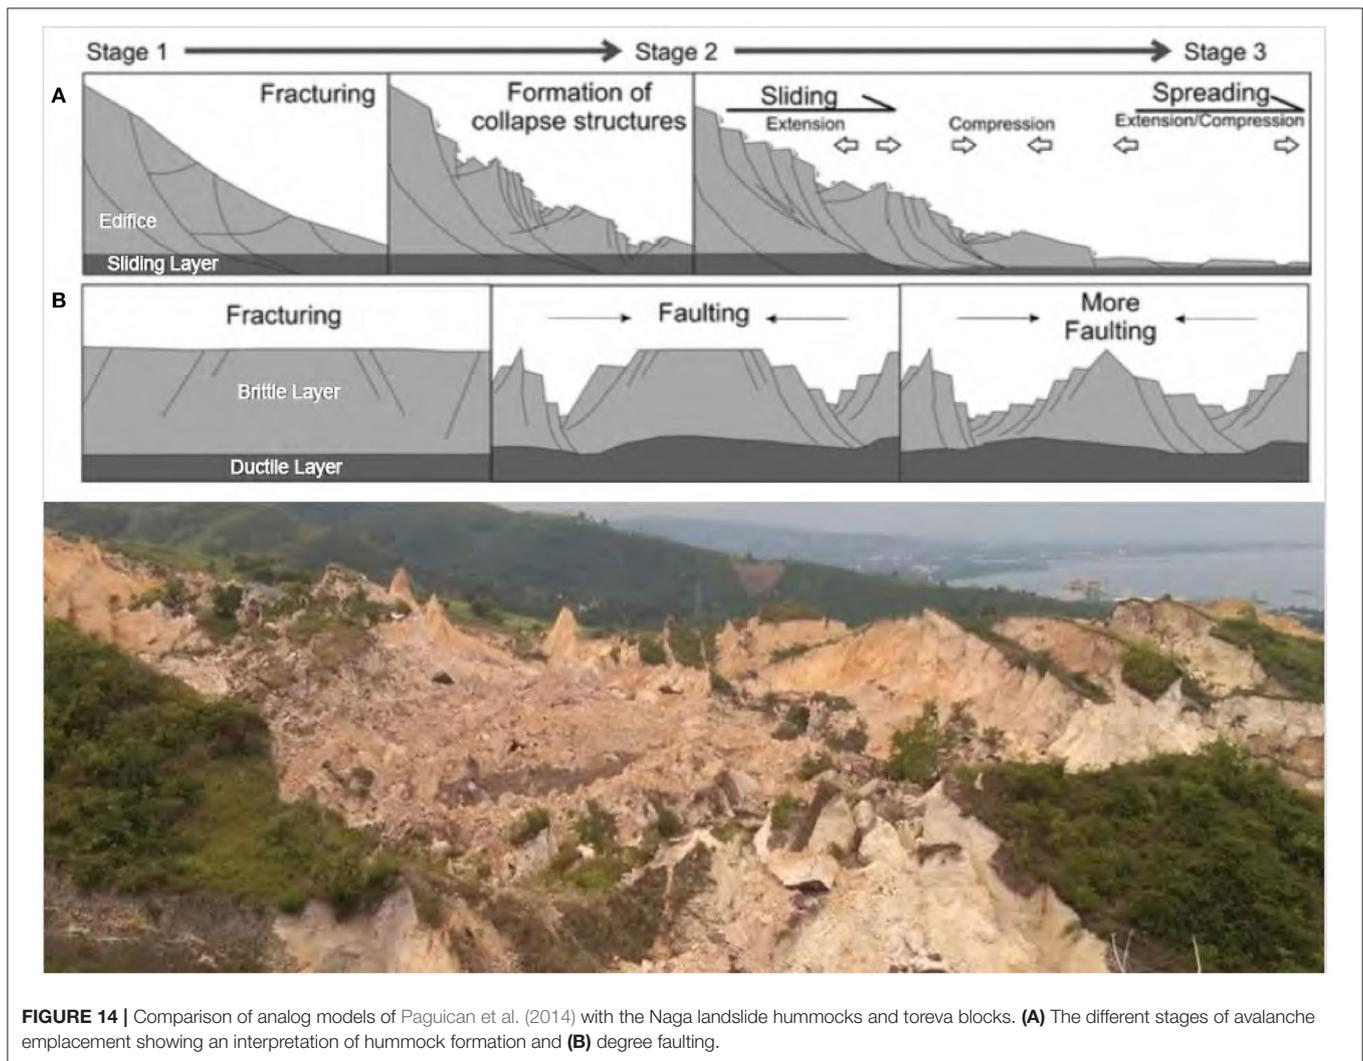
FIGURE 14 | Comparison of analog models of Paguican et al. (2014) with the Naga landslide hummocks and toreva blocks. **(A)** The different stages of avalanche emplacement showing an interpretation of hummock formation and **(B)** degree faulting.

The analog model structures of Paguican et al. (2014), in particular the rotated torevas and hummocks, are consistent with field observations of the Naga landslide and suggest a general brittle slide emplacement (**Figure 14**). The sliding block is composed of brittle limestone, which when extended during transport, forms hummocky structures. Inter-hummocks or those in between hummocks are more broken, finer-grained matrix facies derived from the excessive extension during transport (de Vries and Delcamp, 2015). Hummocks with faults that formed horst and graben structures were preserved within the proximal to medial portions of the Naga landslide deposit field. Thus, the existence of these features imply the presence of sufficient cohesion of the landslide material, such that they remained intact despite the downward movement and spreading.
