Yin X, Zhang F, Wu J, Jia M, Lacidogna G and Xu J (2025) Experimental and numerical analysis on frost heave cracking of prestressed high-strength concrete (PHC) pipe piles in cold regions. *Front. Mater.* 12:1670409. doi: 10.3389/fmats.2025.1670409

Experimental and numerical analysis on frost heave cracking of prestressed high-strength concrete (PHC) pipe piles in cold regions

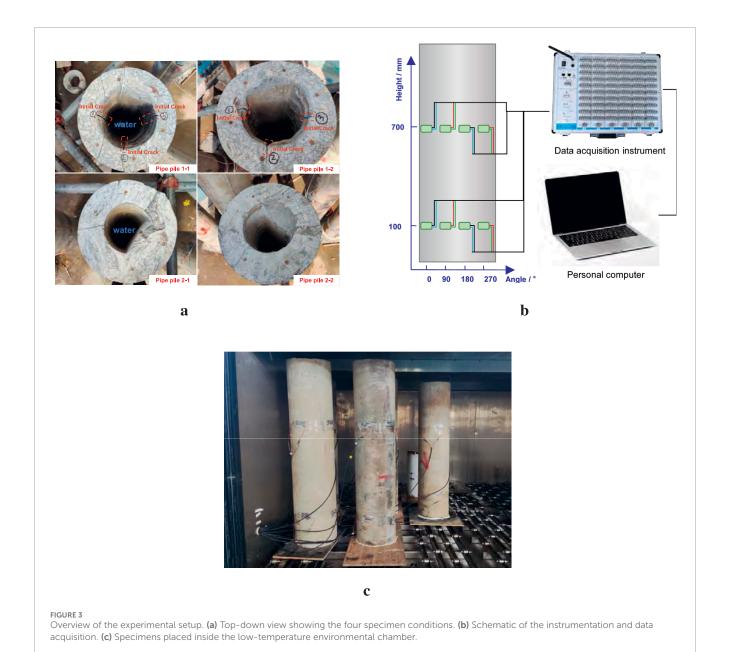
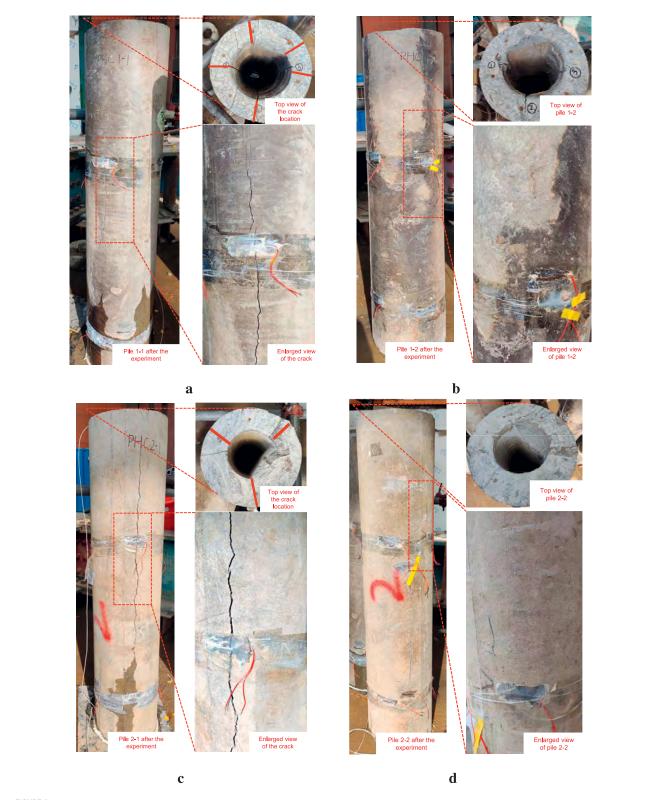
FIGURE 4
The cracking situation of water injection pipe piles. (a) Pile one to one after experiment. (b) Pile one to two after experiment. (c) Pile two to one after experiment. (d) Pile two to two after experiment.

After the test, distinct cracks on both the inner and outer surfaces of Pipe Piles one to one and two to one were observed, as Figure 4a,c shows. The cracks on the inner and outer surfaces corresponded one-to-one in position. Specific data on crack width and length are provided in Table 1. Additionally, the 4-mm-diameter cold-drawn low-carbon steel wire stirrups near the cracks exhibited brittle fracture, with fracture positions concentrated directly ahead of the crack propagation path. This indicates that excessive tensile stress was generated when frost heave force was transmitted to the stirrups.

Pipe Pile one to one developed two through - cracks that developed from the expansion of initial cracks. This occurred because when the pipe pile was subjected to frost heave force from internal water freezing, stress concentration arose at the tips of the initial cracks, making these areas structural weak points. Pipe Pile 2-1—filled with water but without initial cracks—developed three cracks from a single frost heave event. These cracks were located at geometric discontinuities in the inner cross-section (the transition where wall thickness suddenly decreased from 80 mm to 70 mm) and traversed the 9-mm-diameter HPB300 prestressed tendons. This confirms the principle that geometric discontinuities and prestressed tendon locations are prone to cracking.

As Figure 4b,d shows, no visible cracks were observed on the inner or outer surfaces of the control group pipe piles (one to two and 2–2). This further confirms that low-temperature environments alone do not cause cracking—damage occurs only when accumulated water freezes and expands. Conversely, Pile 1–1 (with initial defects) developed more cracks (5) than Pile 2–1 (3). A quantitative comparison of the summary statistics in Table 1 shows that the average crack length and width for Pile 2–1 (101.4 \pm 5.5 cm and 2.30 \pm 1.6 mm) were greater than those for Pile 1–1 (90.7 \pm 14.3 cm and 1.70 \pm 0.9 mm). This may suggest that while initial defects provide more locations for crack initiation, their absence might lead to fewer but more severe cracks under the same frost heave pressure.

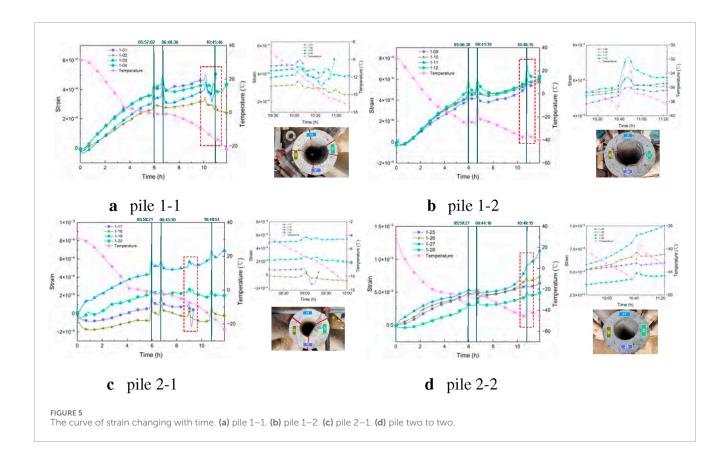
Figure 5 shows the internal temperature changes of the pipe piles during the experiment and the strain data at 700 mm height (no cracks were observed at 100 mm height, so this data is excluded from the analysis). During the test, the test chamber was opened three times for observation (at 5h53min, 6h36min, and 10h43min), causing sudden temperature rises. The strain curves of all groups fluctuated briefly due to this environmental interference, so these fluctuations are excluded from the cracking mechanism analysis.

The correlation between the overall strain trend and frost heave is as follows: In the common change stage from 0 to 9 h (30 °C to -15 °C), the strain trends of the experimental and control groups were nearly identical. Both initially exhibited fluctuations of $\pm 200 - 300\mu\epsilon$ due to concrete shrinkage at low temperatures (some fluctuated from negative to positive, while others remained positive), reflecting the material's general response to temperature gradients. In the differentiation stage after 9 h (when the temperature dropped to \leq -15 °C), strain data from some gauges in the experimental group (1–1, 2–1) begin to deviate from the control group. Specifically,

strains in Channel one and Channel three of Pile one to one, and Channel 17 of Pile two to one, increased from 500 $\mu\epsilon$ to over 1,000 $\mu\epsilon$. Eventually, these gauges were pulled off and failed due to overload, as their positions coincided with the crack propagation paths. In contrast, all channels in the control group (1–2, 2–2) maintained stable strains within $\pm 800\mu\epsilon$, with no sudden overloads.

In summary, all cracking events were accompanied by strain gauge overload failures, and this phenomenon occurred exclusively in the water-injected groups. This confirms that full frost heave of accumulated water inside the pipe piles is a necessary condition for vertical cracking, which ultimately manifests as overload of strain gauges at specific positions.

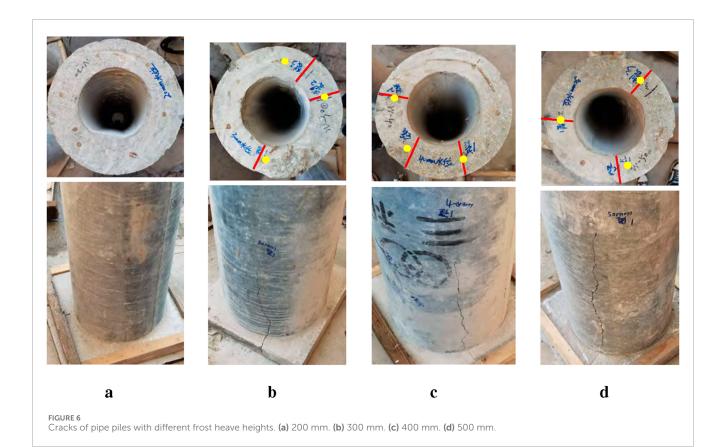
The pipe pile with a 200 mm water level showed no visible cracks as Figure 6a shows. This indicates that the frost heave pressure at this water level did not reach the critical value for cracking. In contrast, the pipe piles with water levels of 300 mm, 400 mm, and 500 mm all developed three cracks (Figures 6b-d). The length and width of the cracks showed significant differences with the increase of water level, as quantitatively analyzed in Figure 7.

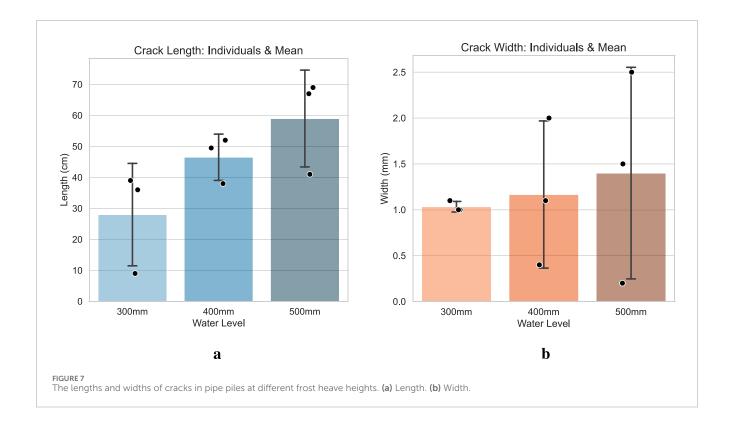
Figure 7 displays the mean, standard deviation, and individual data points for the three cracks observed at each water level. A clear trend was observed: as the water level rose, both the average crack length and width increased. The average crack length grew from 28.0 \pm 16.4 cm at 300 mm to 59.0 \pm 15.1 cm at 500 mm. Similarly, the average crack width increased from 1.03 \pm 0.06 mm at 300mm to 1.40 \pm 1.15 mm at 500 mm. It is also noteworthy that the variability of the measurements, indicated by the standard deviation (error bars) and the scatter of the individual data points, was considerable, especially for the crack width at higher water levels. This highlights the stochastic nature of the cracking process.

The absence of cracking at the 200 mm water level directly confirms the existence of a critical water level threshold (200–300 mm) for frost heave cracking. When the water level is below this threshold, even full freezing of accumulated water generates insufficient expansion force to exceed the tensile strength of C80 concrete. In contrast, at water levels of 300 mm or higher, frost heave pressure increases significantly with rising water levels, causing concurrent growth in crack length and width. Notably, cracks at the 500 mm water level (the highest tested) developed most fully, validating the rule that higher water levels correspond to greater risk and severity of frost heave cracking.

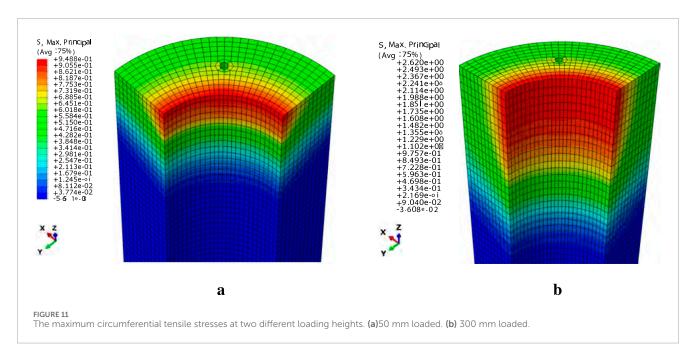
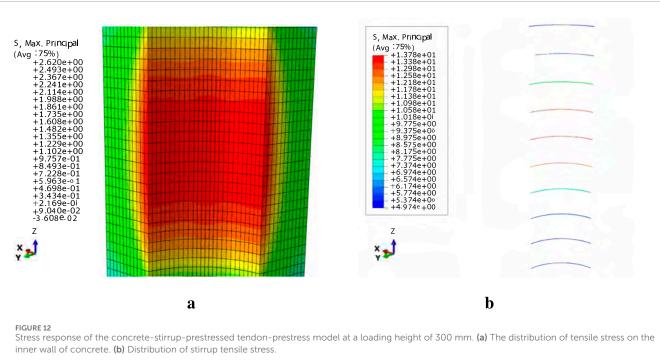
As Figure 12 shows, applying a frost heave pressure of 1.5 MPa results in the maximum circumferential tensile stress in concrete (2.731 MPa) occurring at the central axis of the inner wall. This aligns with the experimental observation that cracks in pipe piles with a 300 mm water level are concentrated in the middle, verifying the model's rationality. Stirrups also exhibit maximum tensile stress in the middle of the loading section, but this value (13.78 MPa) is relatively low compared to their yield stress (320 MPa). This indicates that reinforcement does not significantly share stress when concrete is in the elastic stage. However, the stirrup fracture observed in the experiment strongly suggests that once the concrete

cracks, a significant stress redistribution occurs, transferring load to the reinforcement and eventually causing it to yield or fracture. This discrepancy highlights a key limitation of the current elastic model, which cannot simulate the post-cracking stress redistribution that leads to reinforcement failure.

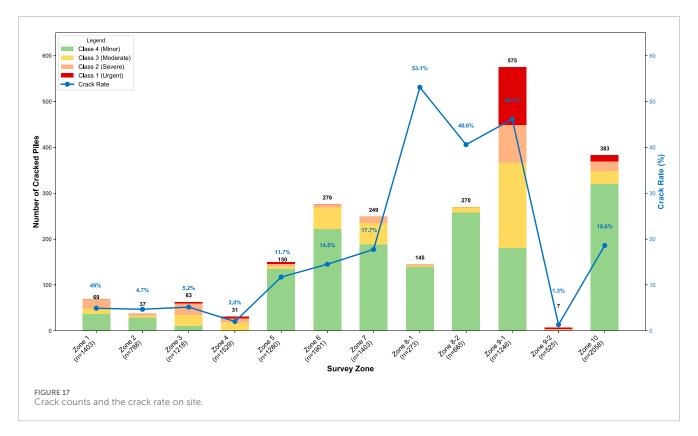
To systematically reveal the distribution patterns, severity of cracks, and their relationship with the total number of piles in each zone, we compiled the crack counts and the crack rate (i.e., the percentage of cracked piles out of the total piles in that zone) into a combined chart (as Figure 17 shhows). In the figure, the stacked bar chart (corresponding to the left Y-axis) visually represents the absolute number of cracks of different severities in each zone, while the blue line chart (corresponding to the right Y-axis) reflects the overall damage proportion of piles in each zone.

From the statistical results in Figure 17, it is clear that the pile damage is not uniformly distributed but exhibits significant regional clustering, mainly reflected in two aspects: (1) High concentration of severe cracks in terms of quantity: The most severe Class 1 and Class 2 cracks (piles requiring urgent repair or reinforcement, totaling 346) are overwhelmingly concentrated in Zone 9–1 (207 piles), Zone 3 (28 piles), and Zone 10 (34 piles). Zone nine to one, in particular, accounts for 81.8% of all Class 1 cracks (126 piles), making it the most severely damaged area in absolute numbers. (2) Significant

differences in crack rates across spatial distribution: As seen from the line chart, some areas exhibit extremely high proportions of damage despite having fewer total piles. The crack rates in Zone eight to one and Zone eight to two reached alarming levels of 53.1% and 40.6% respectively, far exceeding other zones.

A comprehensive analysis indicates that the most severely cracked zones (both in terms of quantity and proportion), namely, Zones 8–1, eight to two, and nine to one, are all "fish-light complementary" zones in the field condition. The sites in these areas are perennially near water, with high surface runoff and groundwater levels. This field
